# Sumas Mountain Asbestos Maps & Photos

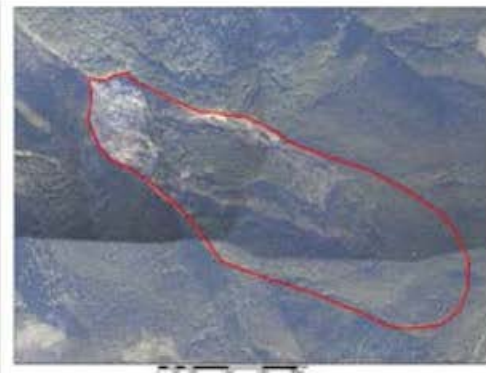
Aerial photo of landslide on Sumas Mountain.

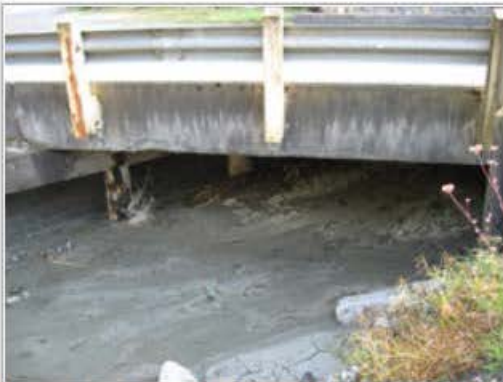
Goodwin Road Bridge - following 2008 dredging of Swift Creek.

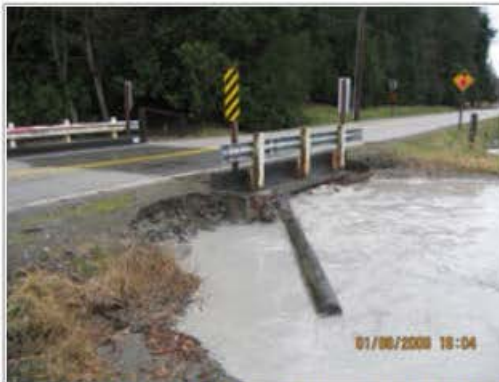
Goodwin Road Bridge after peak flow - January 2009.

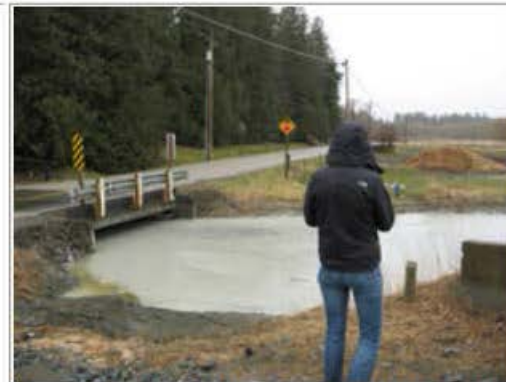
Goodwin Road Bridge after winter flooding - March 2009.

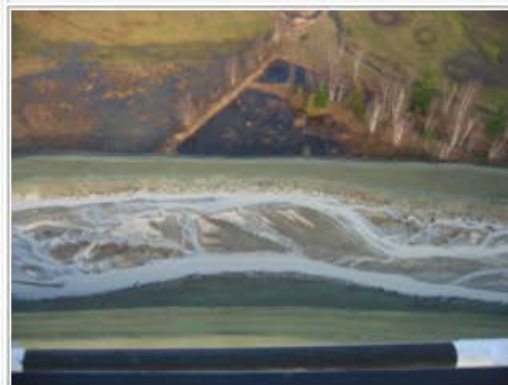
Aerial photo of Swift Creek after high water - January 2009.

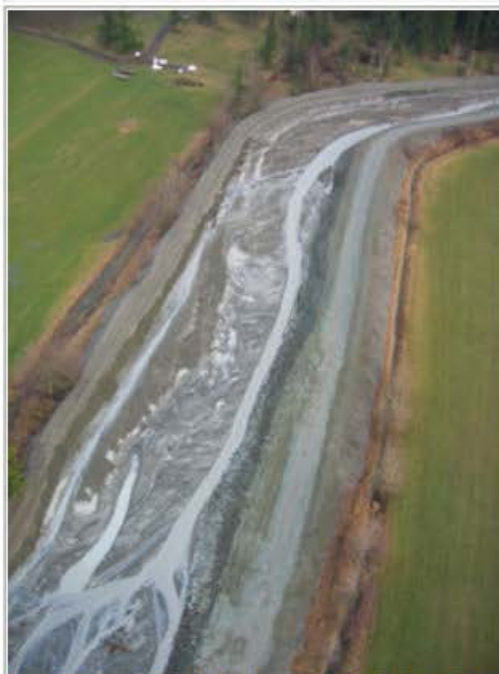
Aerial photo of Swift Creek after high water - January 2009.

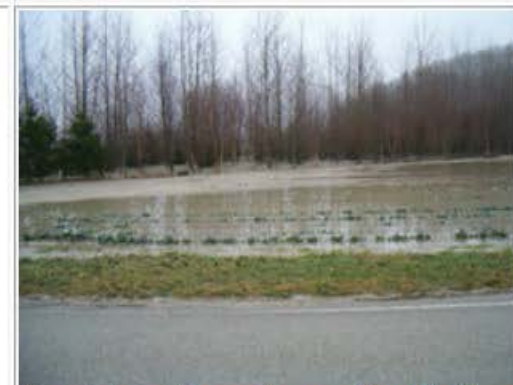
Flood deposits on Sumas farm field - after January 2009 flooding.

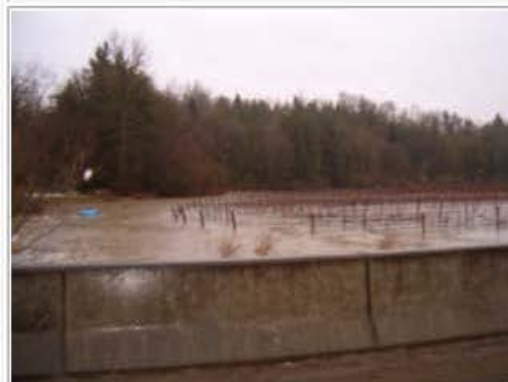
Flooded farm fields - January 2009.

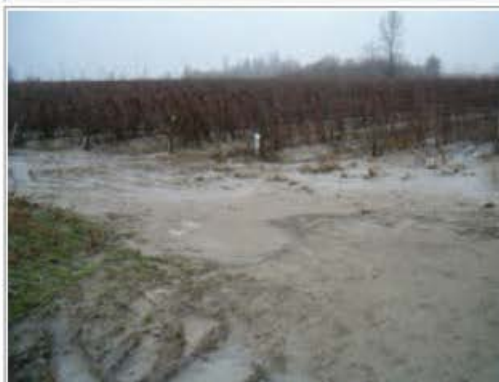
Flood deposits on Sumas farm field - after January 2009 flooding.

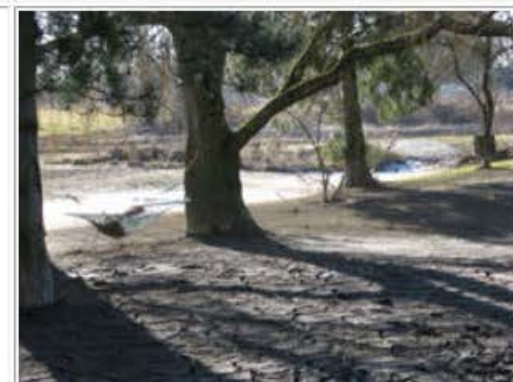
Residential property along Sumas with flood deposits from January 2009.

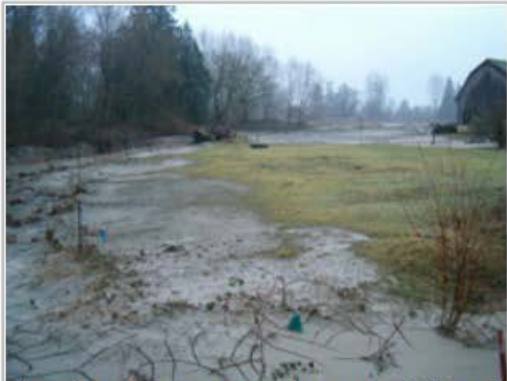
Flooding from Sumas (river on left side) - January 2009.

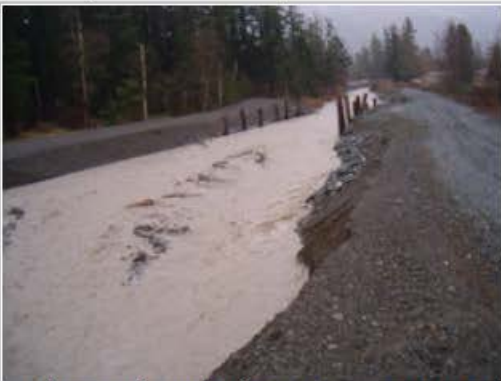
Swift Creek at high water - January 2009.

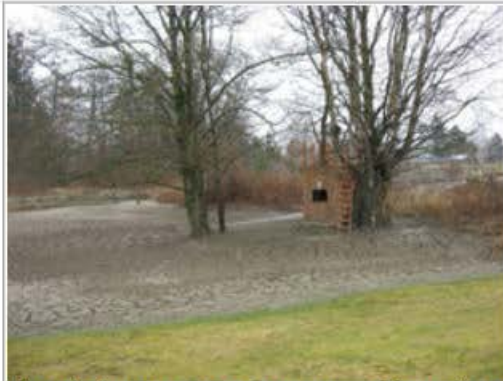
Flood deposit on Sumas residential yard - February 2009.

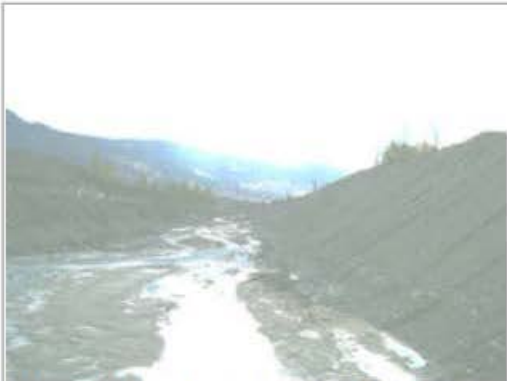
Stockpiled sediments along Swift Creek channel - 2005.

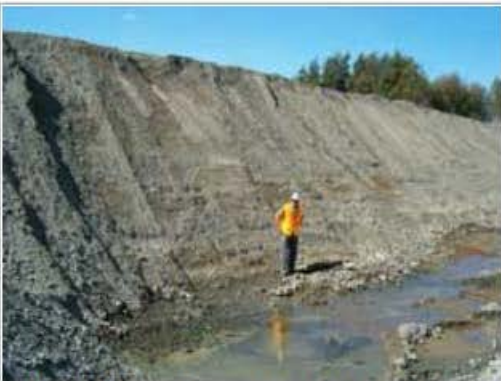
The dredge piles reach 10-15 feet high in some areas - 2005.

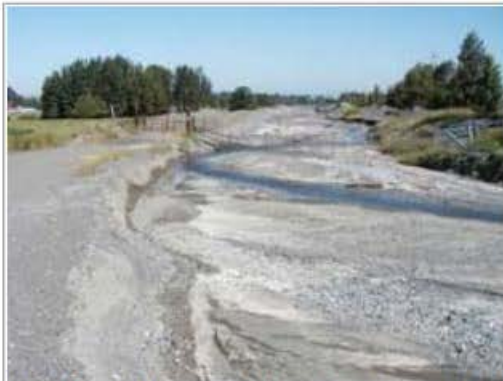
Swift Creek channel between Goodwin and Oat Coles Roads before dredging - 2004.

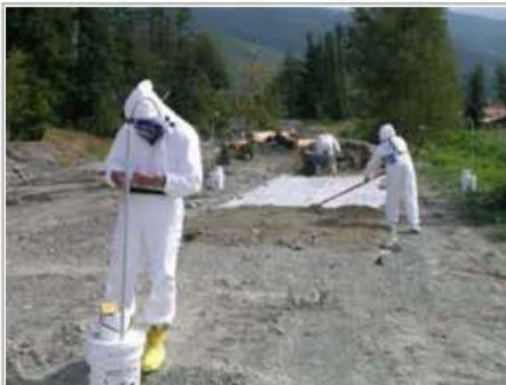
EPA staff generate dust by raking and other activities and then collect air samples- Summer 2006.

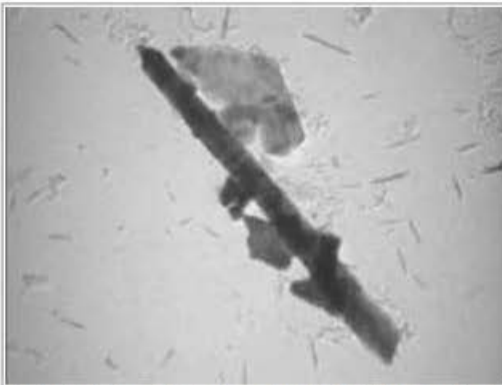
Actinolite asbestos fiber from Swift Creek viewed in a Transmission Electron Microscope.

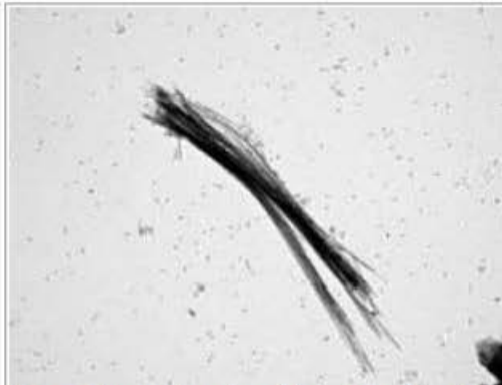
Chrysotile asbestos fiber from Swift Creek viewed in a Transmission Electron Microscope.
